Ontario Ministry of Transportation

**Highway 17 Planning & Class EA Study  
Fisheries Report  
GWP 5670-10-00**

AECOM

July, 2014

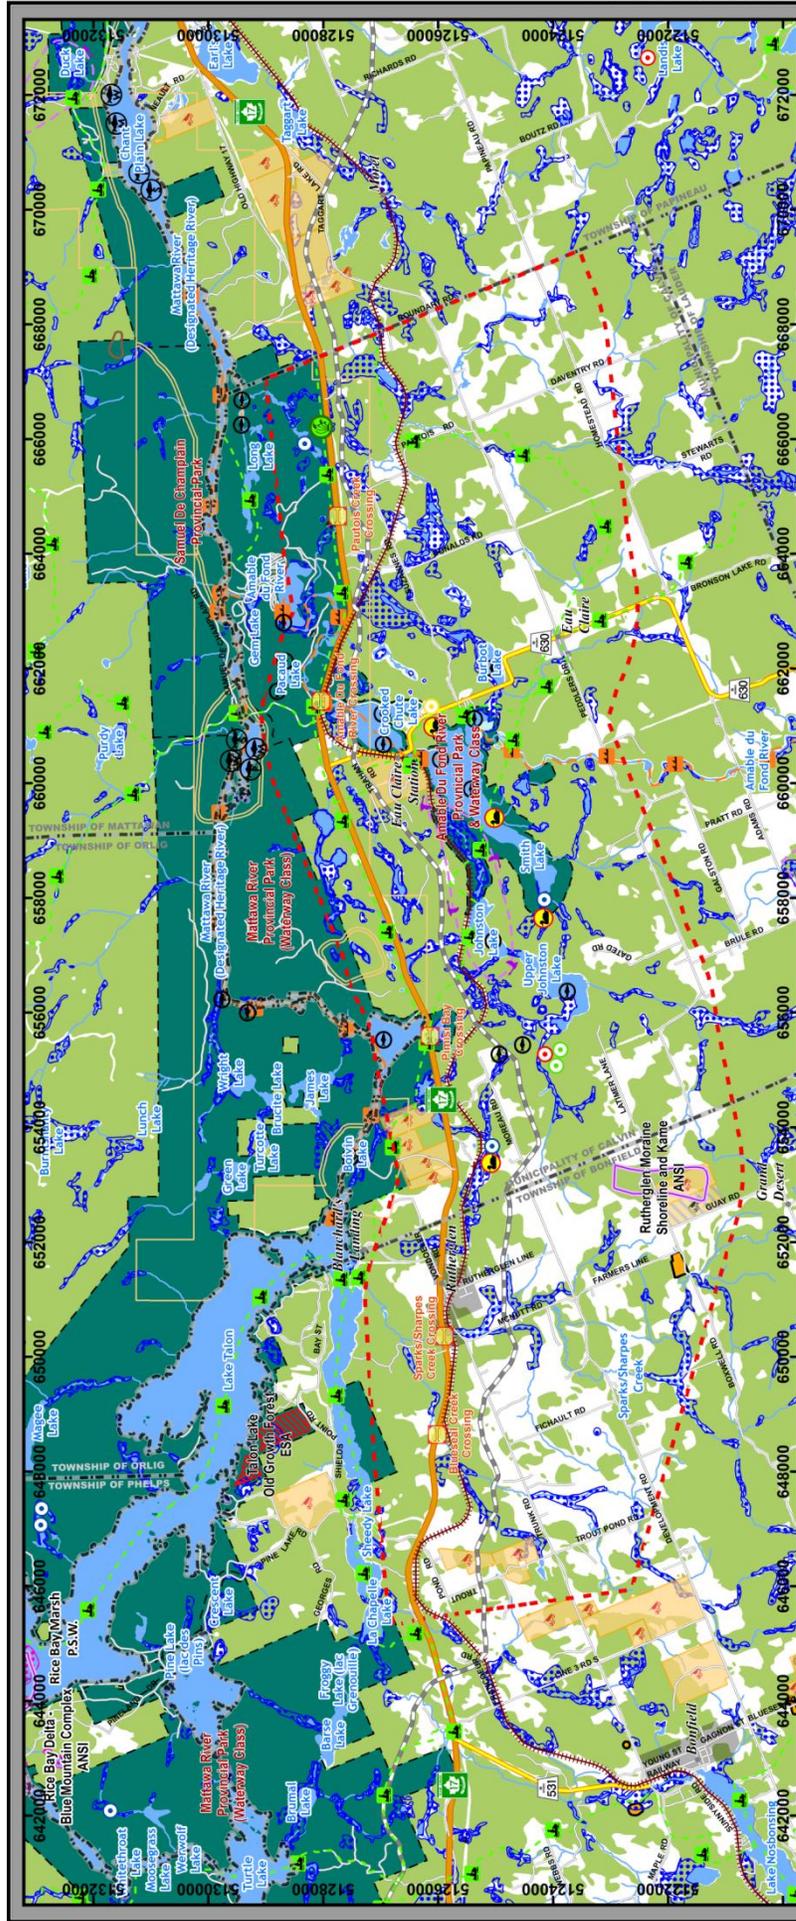
Figure 1.2: Environmental Constraints Mapping

Highway planning alternatives were generated with a freeway cross section comprised of two lanes in each direction, a 30m median within a total right-of-way width of 110m, and access restricted to interchanges. Consideration was given to the environmental constraints within the Study Area are shown on **Figure 1.2**.

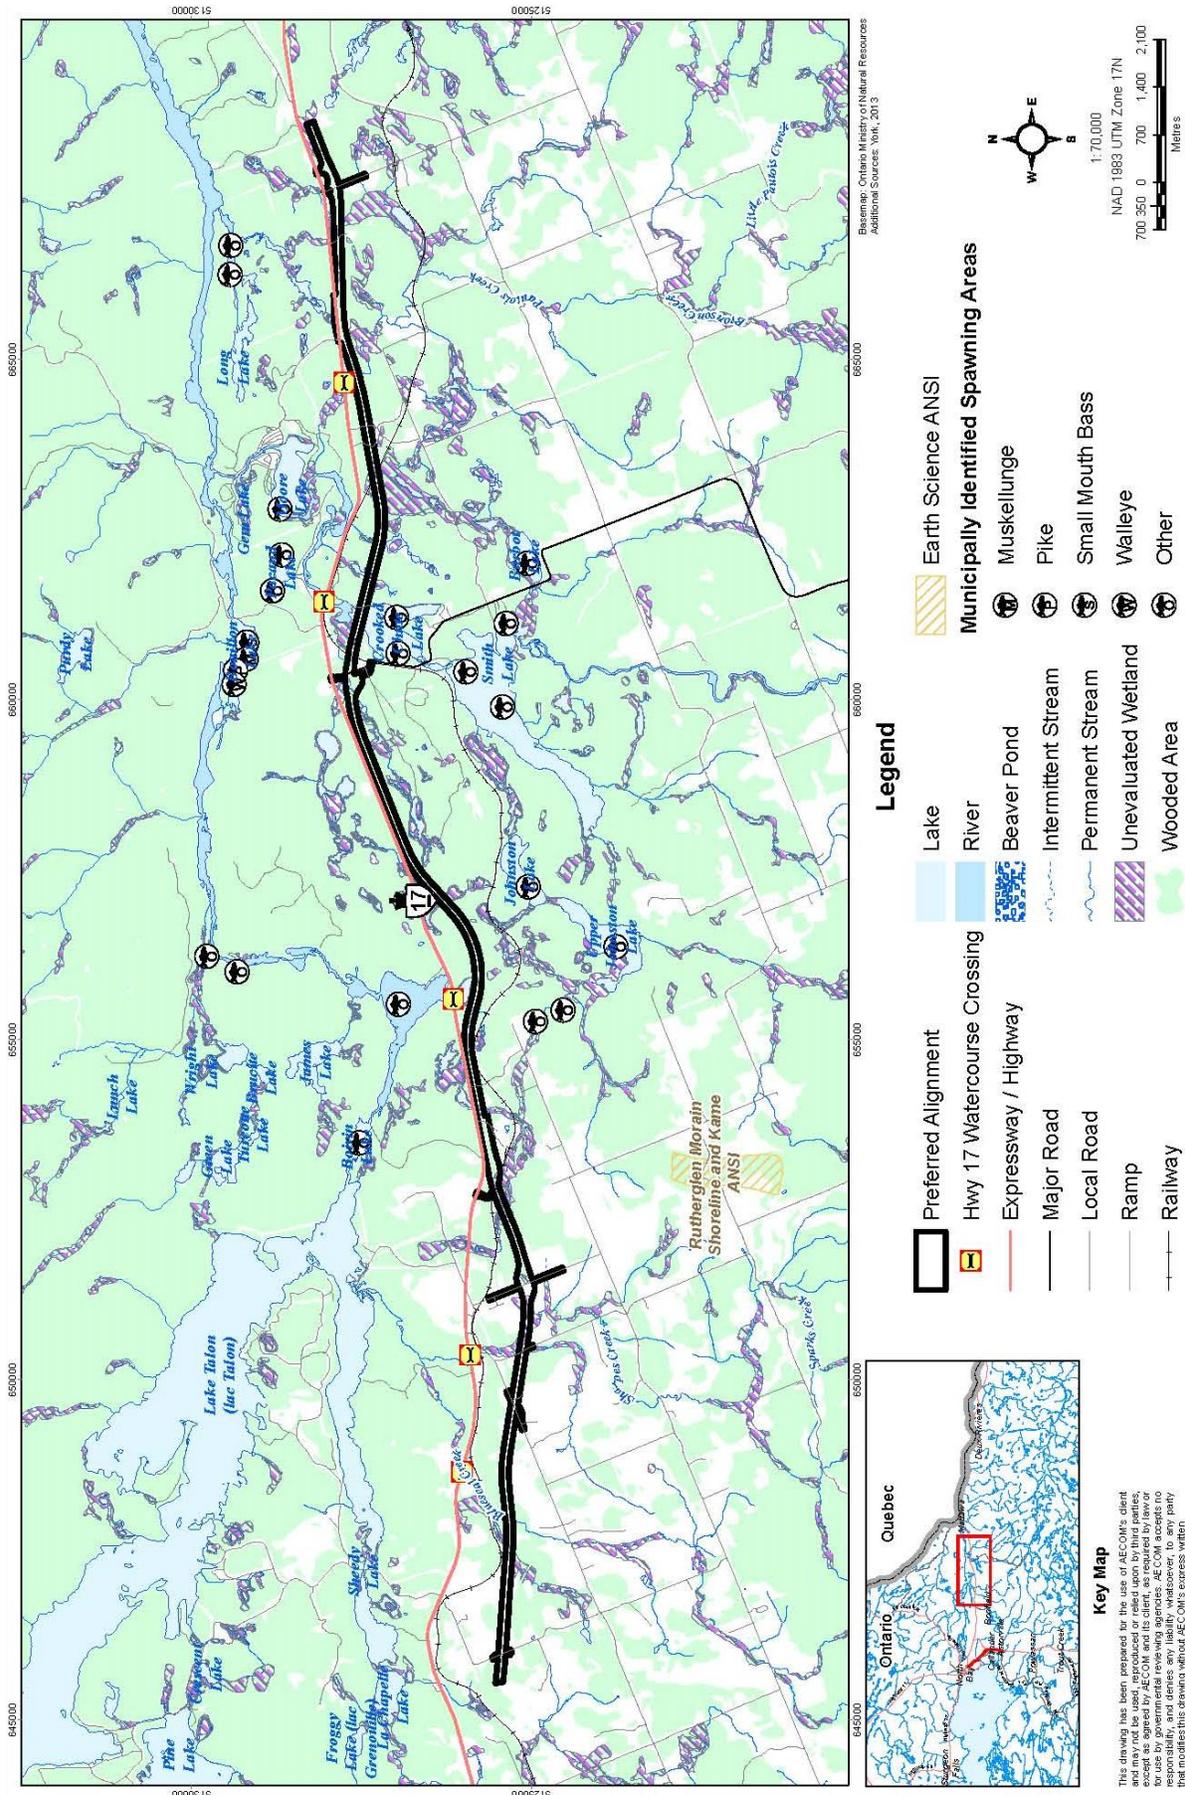
Figure 1.3: Recommended Plan and Environmental Constraints

alternative areas (with associated interchanges and service roads) and a recommended plan was identified in January 2014 as shown on **Figure 1.3**.

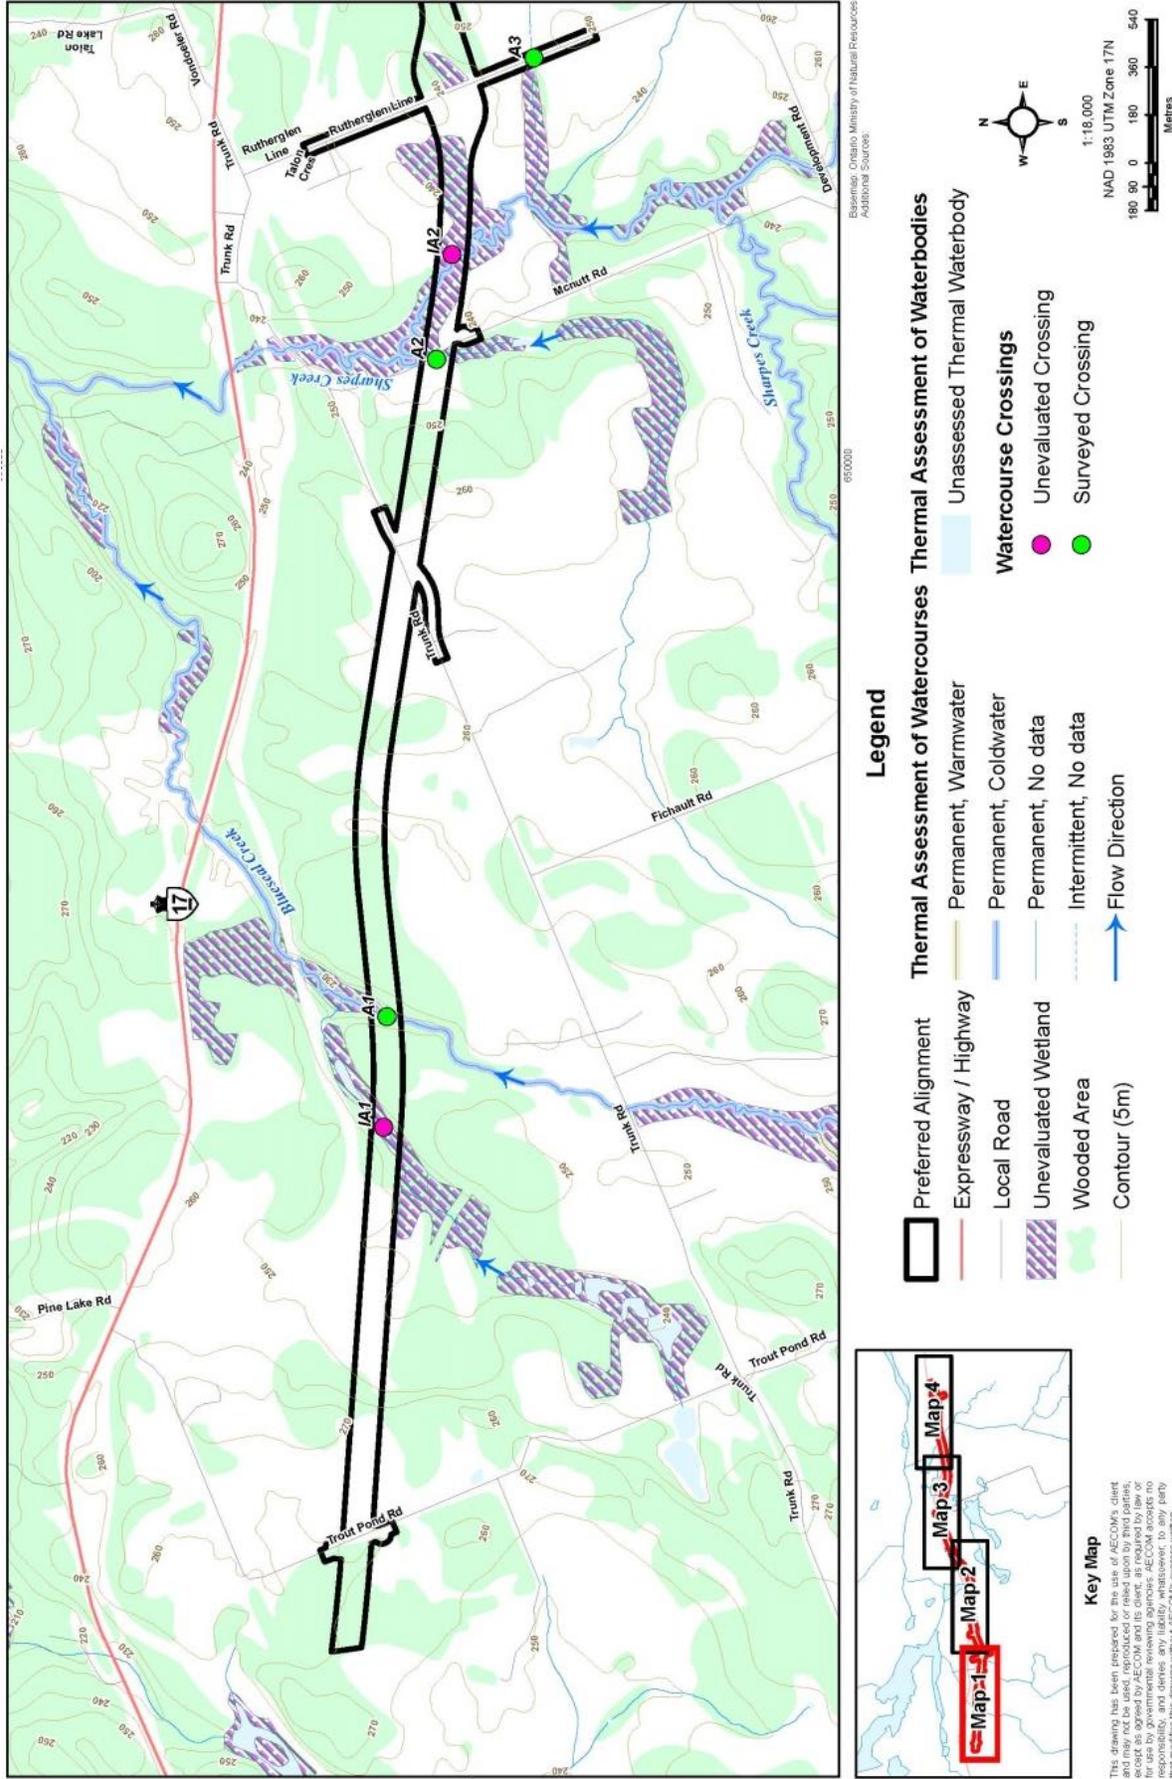
**Figure 3.1: Aquatic Habitat Survey Sites**

the approximate width of the recommended plan. Site locations, both unevaluated and assessed, are listed in **Table 3.1-1** below and are shown on **Figures 3.1 to 3.4**.

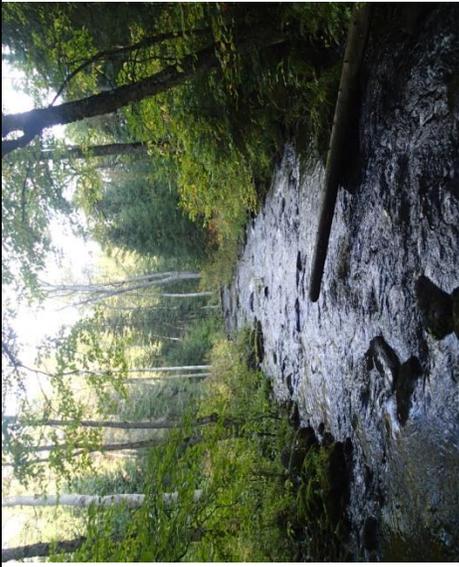
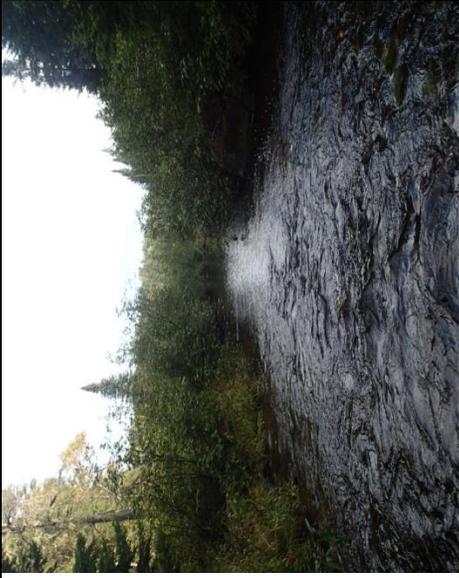
<p>Water chemistry:                      temperature = 11.64°C; pH = 6.68; conductivity = 37 µS/cm; dissolved oxygen = 13.82 mg/L.</p>		(m)	(m)	MWV	5	MWV	MBW	6	MBD			0.6	<p>Coldwater system with Brook Trout.</p> <p>School of cyprinids observed.</p> <p>Potentially Brook Trout spawning, gravel bed at beginning of riffle area.</p> <p>Landowner says he has caught Brook Trout in last 3 years.</p>
	(m)	(m)															
MWV	5	MWV															
MBW	6	MBD															
		0.6

<p><b>Photograph 1.</b>                      Overview of channel at upstream end, looking downstream.</p>	<p><b>Photograph 2.</b>                      Overview of channel at downstream end, looking downstream.</p>

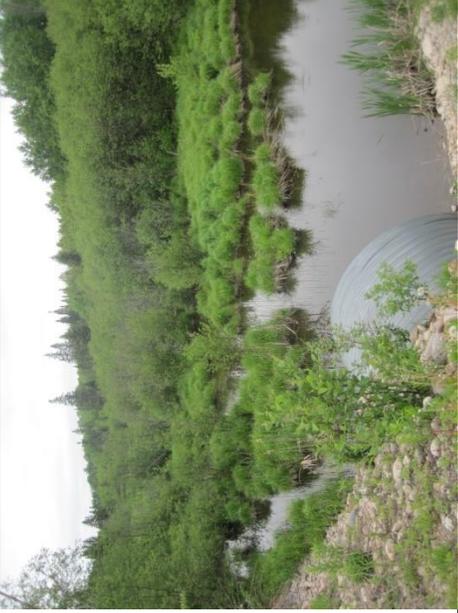
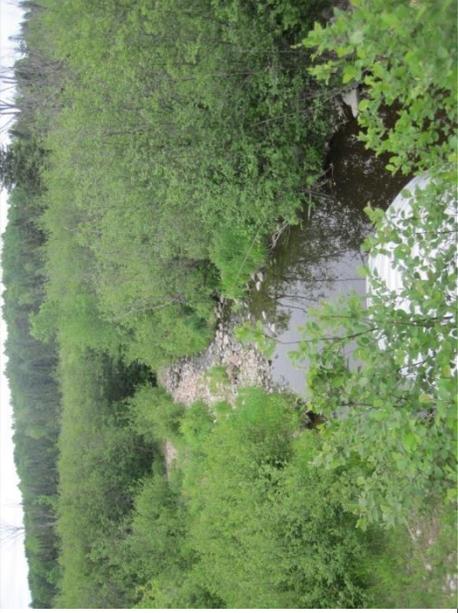
**Table 3.3: Fish habitat assessment for Site A2**

<p>Water chemistry (June 2013):                      temperature = 14.57°C; pH = 7.53; conductivity = 140 µS/cm; dissolved oxygen = 4.86 mg/L.</p>		(m)	(m)	MWW	3.75	MWD	MBW	5	MBD			0.7	Less than 200m downstream the tributary connects to Sharpes Creek which is a coldwater system, with Brook trout present.
	(m)	(m)															
MWW	3.75	MWD															
MBW	5	MBD															
		0.7

<p><b>Photograph 1.</b>                      Overview, looking upstream (west) from McNutt Road.</p>	<p><b>Photograph 2.</b>                      Overview, looking downstream (east) from McNutt Road.</p>

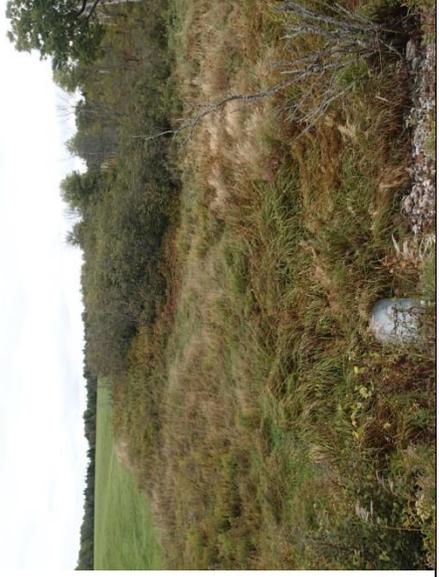
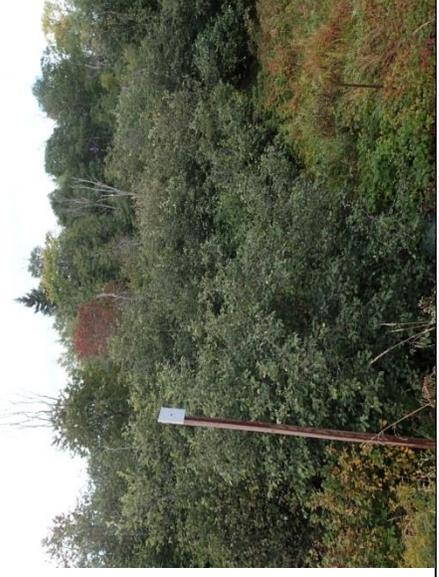
**Table 3.4: Fish habitat assessment for Site A3**

<p>Water chemistry:                      temperature = 8.51 °C; pH = 4.93; conductivity = 25 µS/cm;                      dissolved oxygen = 0.65 mg/L.</p>		(m)	(m)	MWW	1.0	MWD 0.10	MBW	1.5	MBD 0.25	
	(m)	(m)												
MWW	1.0	MWD 0.10												
MBW	1.5	MBD 0.25

<b>Photograph 1.</b> Overview, looking upstream (east) from Rutherglen Line.	<b>Photograph 2.</b> Overview, looking downstream (west) from Rutherglen Line.

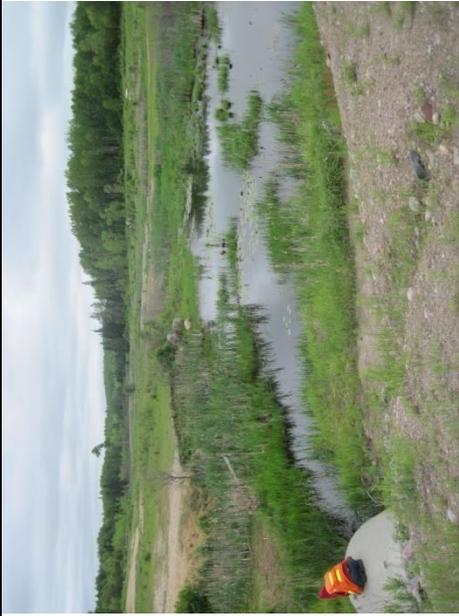
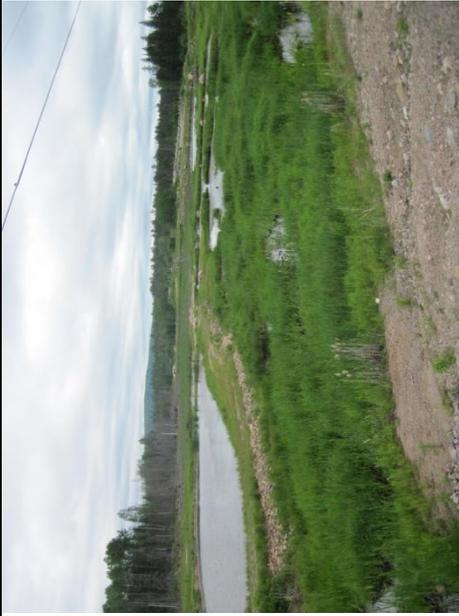
**Table 3.5: Fish habitat assessment for Site A4**

<p>Water chemistry: temperature = 16.38°C; pH = 7.29; conductivity = 197 µS/cm; dissolved oxygen = 5.22 mg/L.</p>		(m)	(m)	MWW	20	MWD	MBW	20	MBD			n/a			n/a	School of cyprinid fish observed during investigation.
	(m)	(m)																		
MWW	20	MWD																		
MBW	20	MBD																		
		n/a																		
		n/a

<b>Photograph 1.</b> Overview, looking upstream (south) from Hwy 17.	<b>Photograph 2.</b> Overview, looking downstream (north) from Hwy 17.

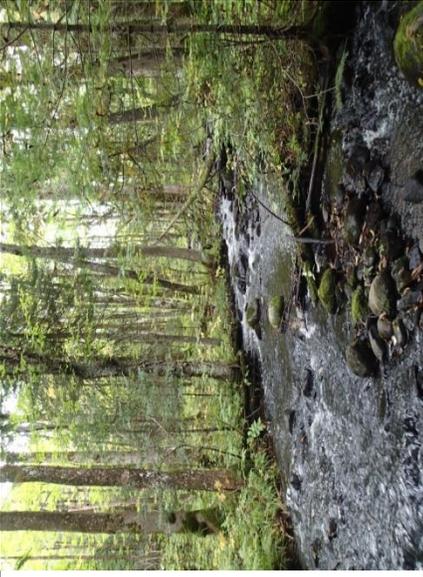
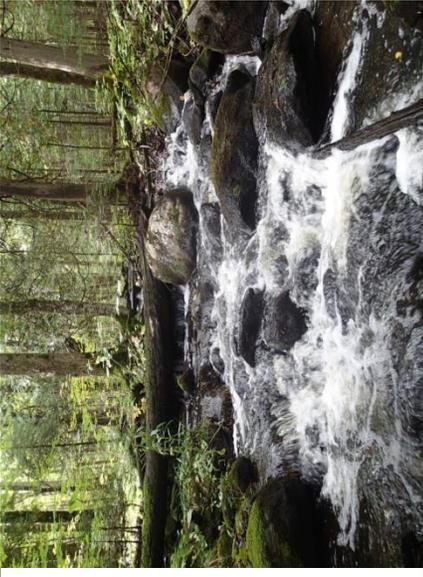
**Table 3.6: Fish habitat assessment for Site A5**

<p>Water chemistry:                      temperature = 10.43°C; pH = 6.9; conductivity = 180 µS/cm;                      dissolved oxygen = 13.14 mg/L.</p>		(m)	(m)	MWW	3.0	MWD	0.25	MBW	3.8	MBD	0.55	A young of the year Brook Trout was observed in the upper reaches of the watercourse indicating spawning activities in the system. Gravel islands observed throughout.
	(m)	(m)														
MWW	3.0	MWD	0.25													
MBW	3.8	MBD	0.55

<b>Photograph 1.</b> Overview, looking downstream in the upper reaches of the tributary	<b>Photograph 2.</b> High gradient section in the upper reaches of the tributary

- Site A12, located in Pautois Creek, there is a large stretch of ideal Brook Trout spawning habitat that measures ~1800m<sup>2</sup>. No spawning activities observed at the time of investigation.
- Site A5, located in Pimisi Bay Tributary, a young of the year Brook Trout was observed in the upper reaches of the watercourse indicating spawning activities in the system. Gravel beds observed throughout the study area.
- Site A1, located Bluseal Creek, ideal gravel bed observed in watercourse that could potentially be used for Brook Trout spawning. Landowner has caught Brook Trout in last three (3) years.

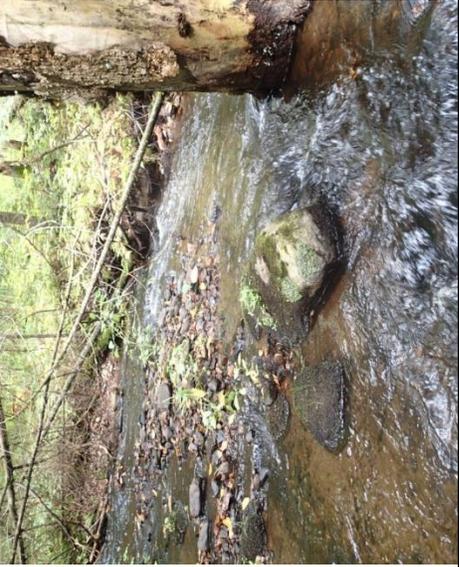
<p><b>Photograph 3.</b>                      Overview of channel.</p>

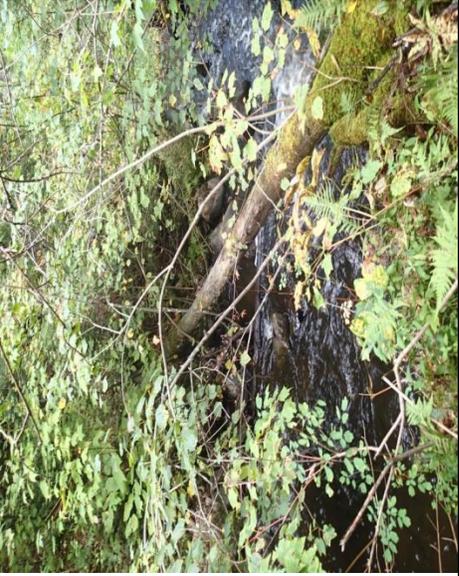
<p><b>Photograph 4.</b>                      Overview of channel in lower gradient section.</p>

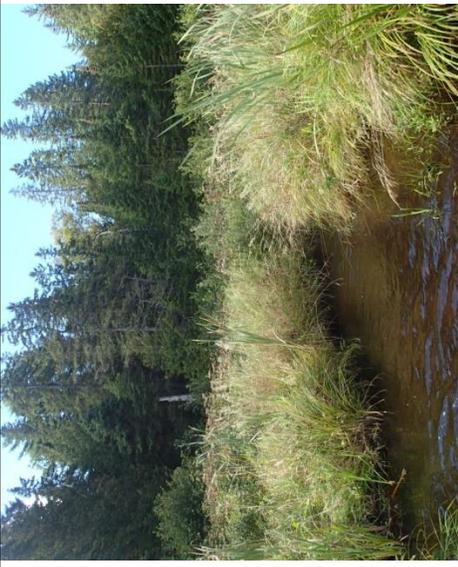
<p><b>Photograph 5.</b>                      Tributary as it enters Pimisi Bay.</p>

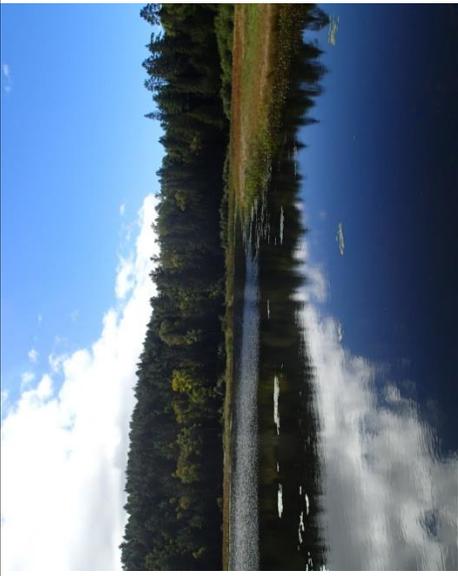
<p><b>Photograph 6.</b>                      Overview of Pimisi Bay from Hwy 17.</p>

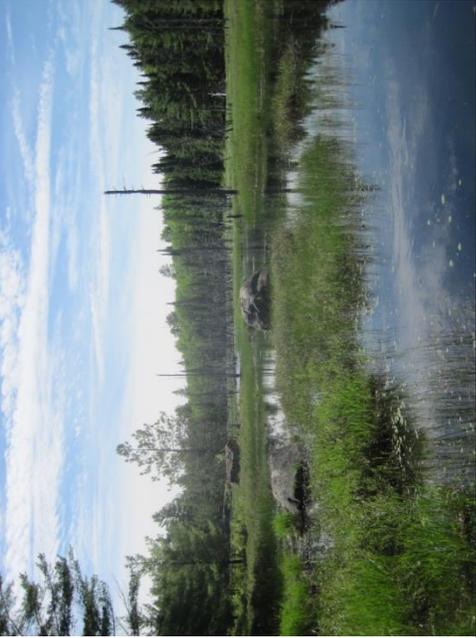
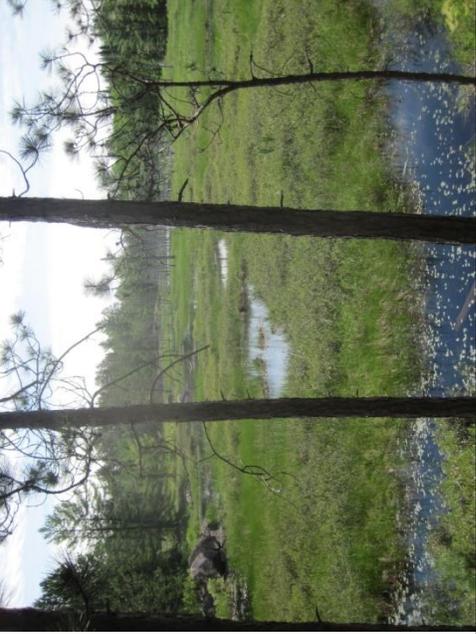
**Table 3.7: Fish habitat assessment for Site A6**

<b>Photograph 1.</b> Overview of waterbody.	<b>Photograph 2.</b> Depression area within forest.

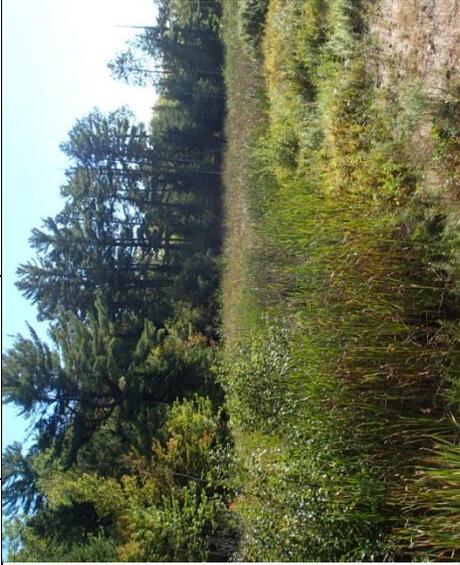
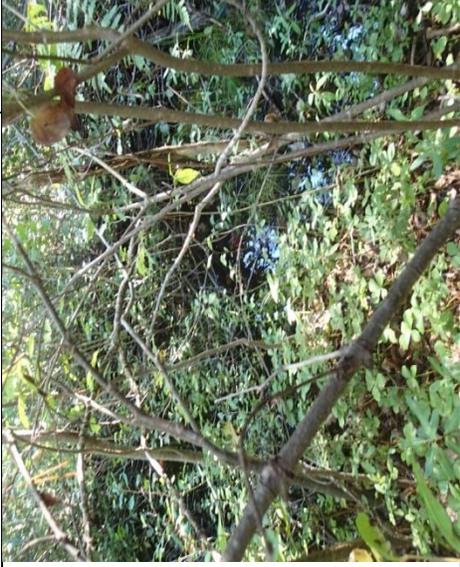
**Table 3.8: Fish habitat assessment for Site A7**

<p>Water chemistry:                      temperature = 9.62°C; pH = 4.54; conductivity = 265 µS/cm;                      dissolved oxygen = 3.40 mg/L.</p>		(m)	(m)	MWW	1	MWVD	MBW	n/a	MBD			n/a	Watercourse is mapped as a permanent stream but poorly defined channel with organic debris as substrate, and likely dries up in the summer, suggesting it is intermittent
	(m)	(m)															
MWW	1	MWVD															
MBW	n/a	MBD															
		n/a

<b>Photograph 1.</b> Overview of site from Hwy 17. Cattail marsh area then forest.	<b>Photograph 2.</b> Depression area within forest.

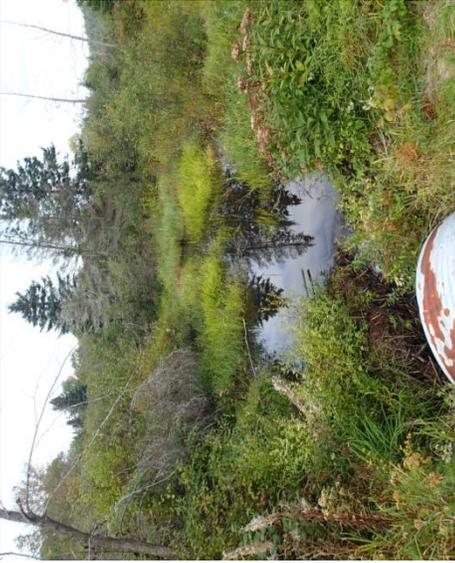
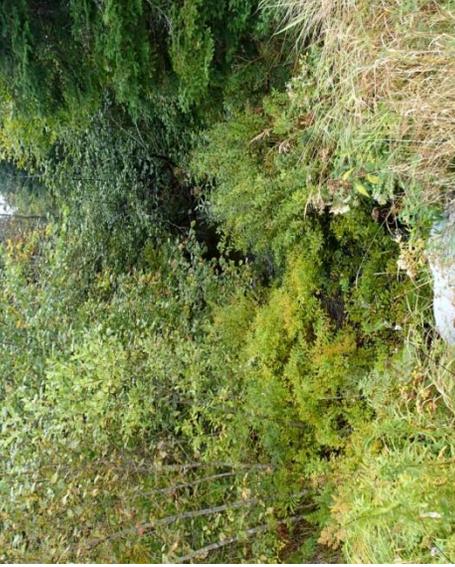
**Table 3.9: Fish habitat assessment for Site A8**

<p>Water chemistry: temperature = 13°C; pH = 6.49; conductivity = 148 µS/cm; dissolved oxygen = 13.32 mg/L.</p>		(m)	(m)	MWW	4	MWD	MBW	n/a	MBD			n/a	Gravel beds observed in the downstream reach
	(m)	(m)															
MWW	4	MWD															
MBW	n/a	MBD															
		n/a

<p><b>Photograph 1.</b>                      Overview of watercourse upstream, from Hwy 630. Looking west.</p>	<p><b>Photograph 2.</b>                      Overview of watercourse downstream, from Hwy 630. Looking east.</p>

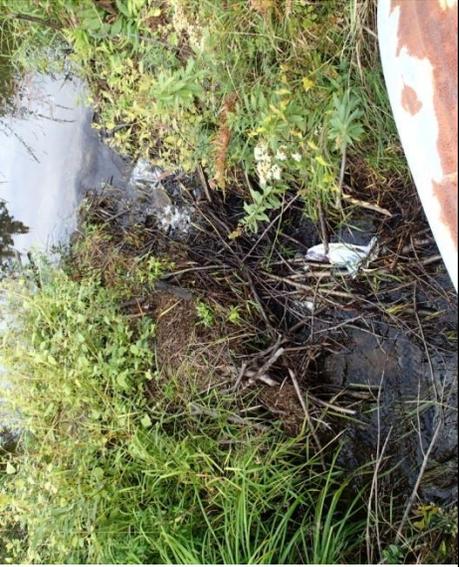
<p><b>Photograph 3.</b> Beaver dam on upstream side of culvert.</p>

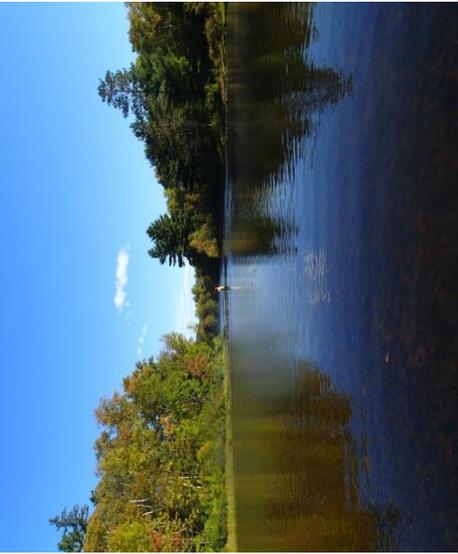
<p><b>Photograph 1.</b>                      Looking downstream from the bay area.</p>

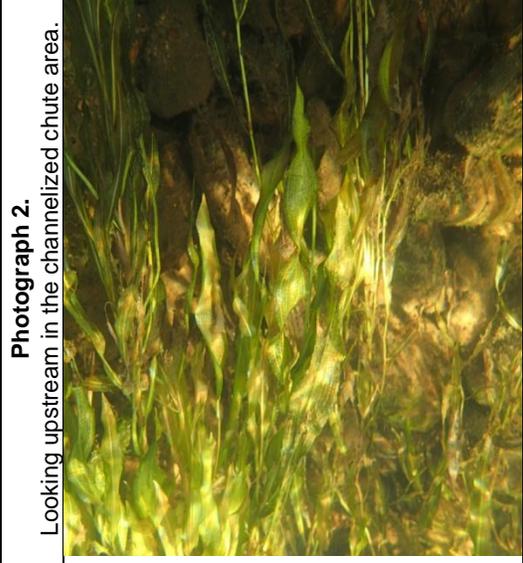
<p><b>Photograph 2.</b>                      Looking upstream in the channelized chute area.</p>

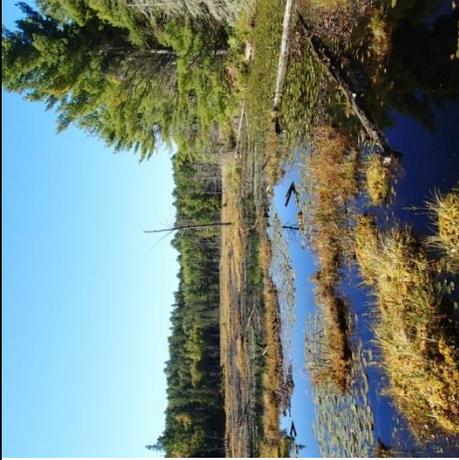
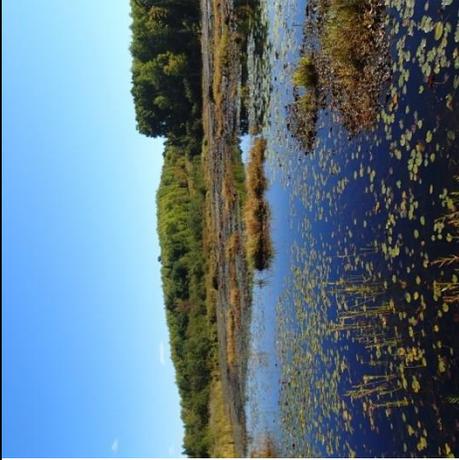
**Table 3.11: Fish habitat assessment for Site A10**

<p>Water chemistry:                      temperature = 13.2°C; pH = 5.50; conductivity = 24 µS/cm; dissolved oxygen = 2.30 mg/L.</p>

<p><b>Photograph 1.</b>                      Overview of pond looking south.</p>	<p><b>Photograph 2.</b>                      Overview of pond looking east.</p>

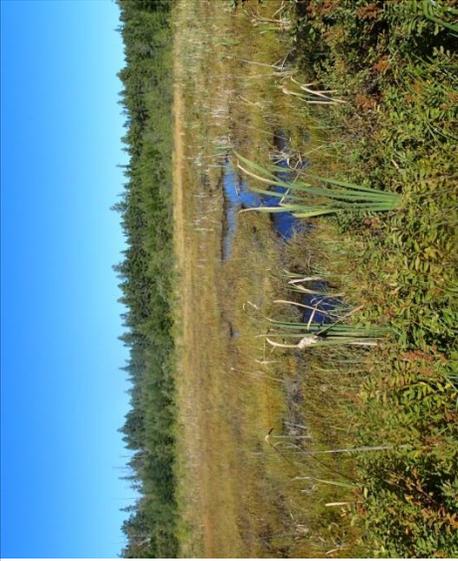
<p><b>Photograph 1.</b> Wetland area north of rail line.</p>

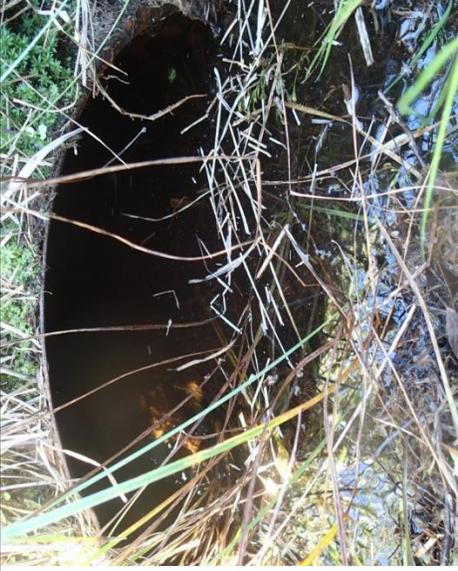
<p><b>Photograph 2.</b> Culvert outlet of watercourse.</p>

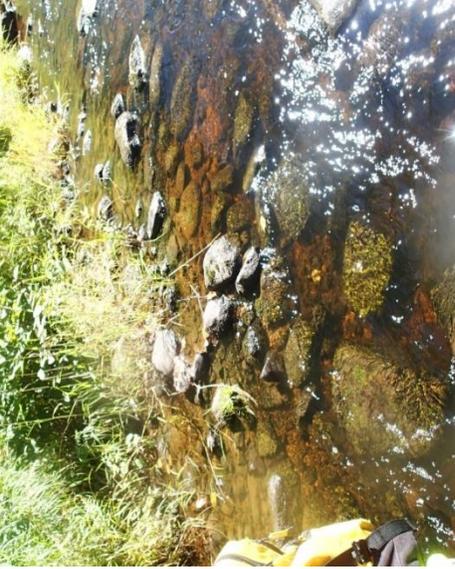
<p><b>Photograph 3.</b> Channel substrate.</p>

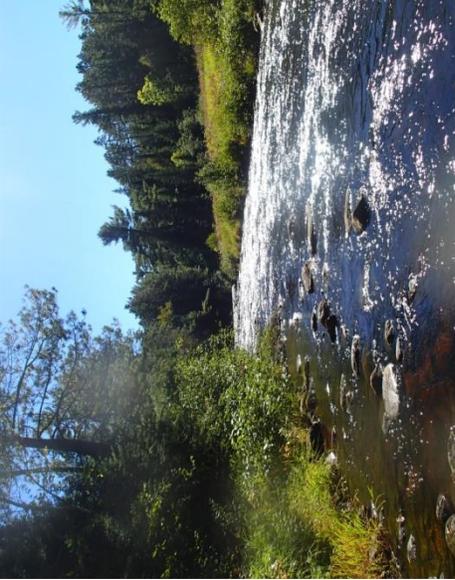
<p><b>Photograph 4.</b> Overview of channel looking downstream, with pipeline noted on right bank.</p>

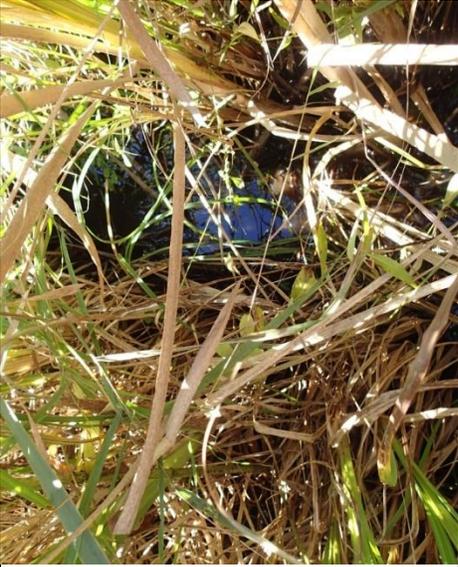
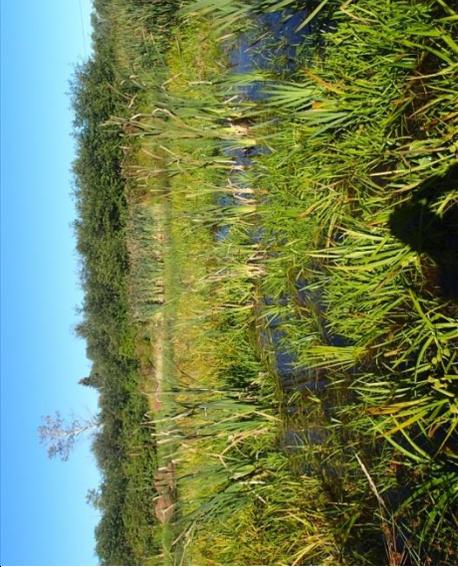
**Table 3.14: Fish habitat assessment for Site A13**

<p><b>Photograph 1.</b>                      Watercourse flowing through cattails.</p>	<p><b>Photograph 2.</b>                      Wetland area immediately south of Hwy 17.</p>

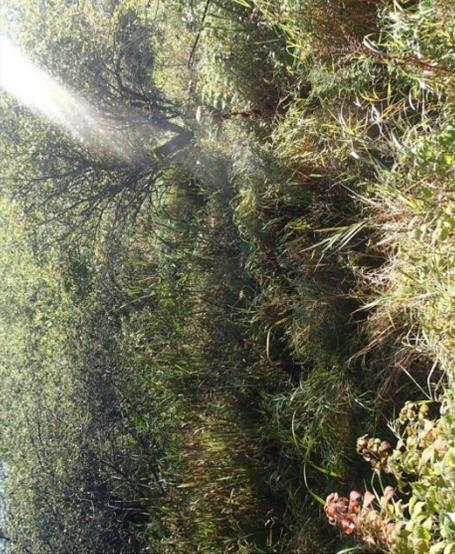
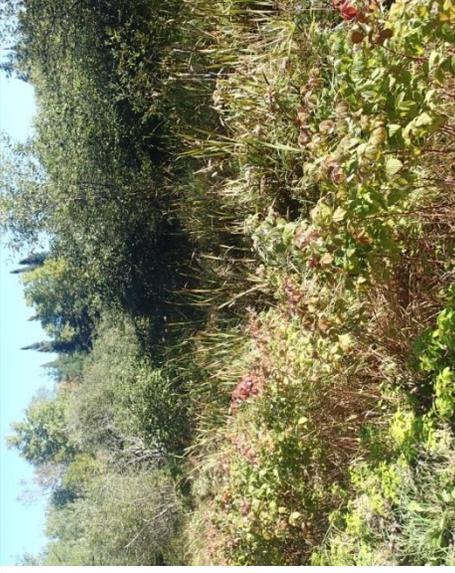
**Table 3.15: Fish habitat assessment for Site A14**

<p>Water chemistry: temperature = 7.45°C; pH = 5.48; conductivity = 31 µS/cm; dissolved oxygen = 10.04 mg/L.</p>		(m)	(m)	MWW	1.75	MWD	0.25	MBW	1.85	MBD	0.55	Headwater to Pautois Creek.
	(m)	(m)														
MWW	1.75	MWD	0.25													
MBW	1.85	MBD	0.55

<p><b>Photograph 1.</b>                  Overview of upstream side from Boundary Road.</p>	<p><b>Photograph 2.</b>                  Overview of downstream side from Boundary Road.</p>
